EGR Cooler Cleaning Solution Evaluation – HZ EGRC2

Cleaned 2/23/2012 & 2/24/2012

Kim McKinnon,
Paccar Technical Center ETL
2/28/2012

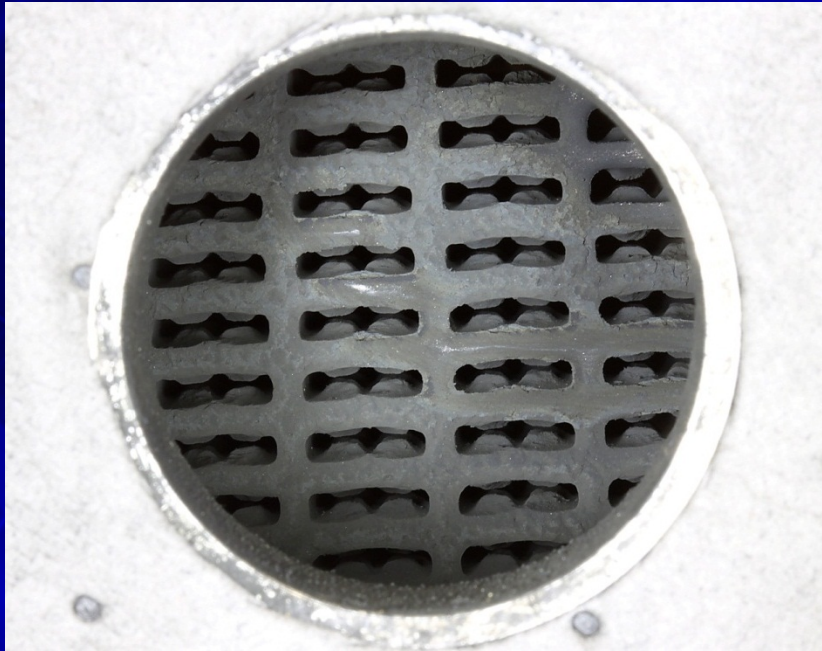
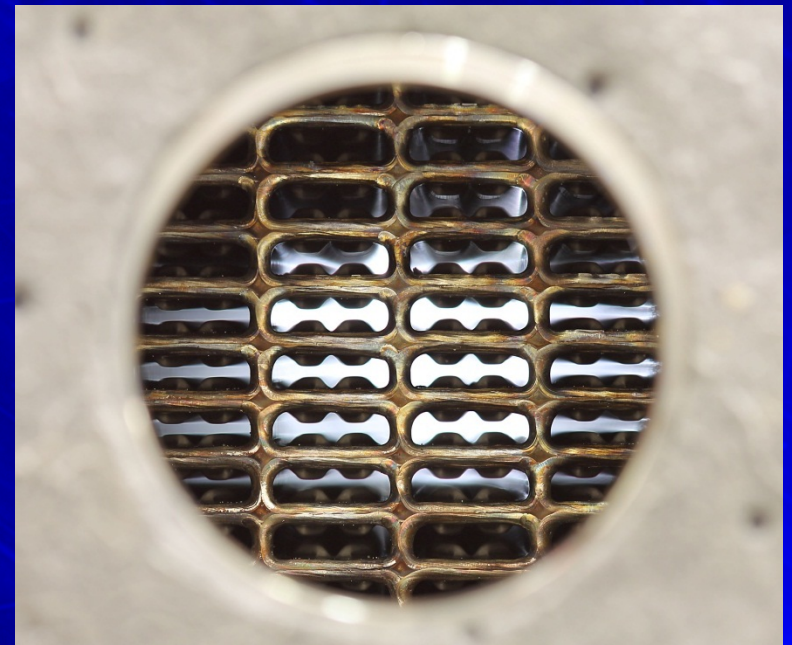
Test Sample #2

Case ID 2566529, 9/13/2011 – 18806 miles

| | #blocked | #restricted | #clear |
| Before | 0 | 36 | 0 |
| After | 0 | 0 | 36 |

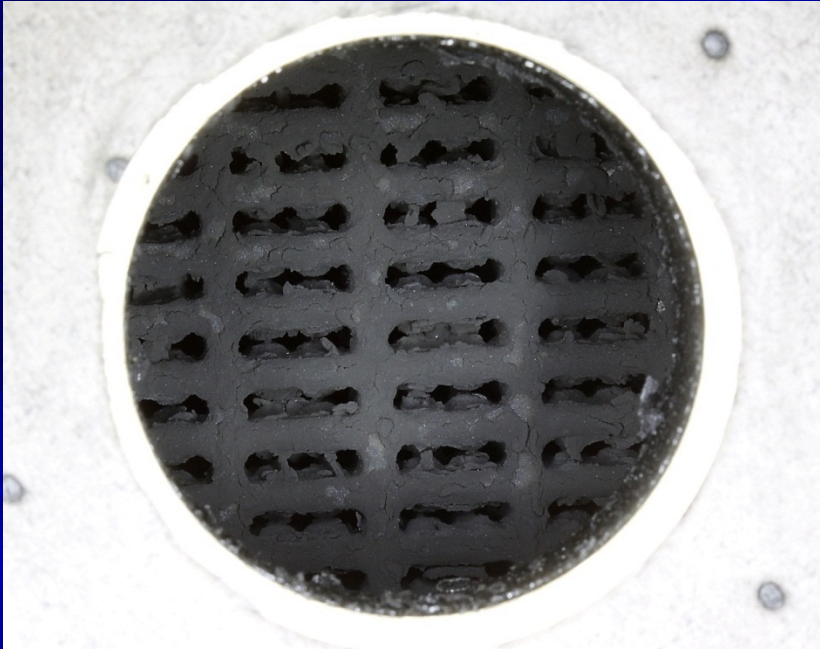
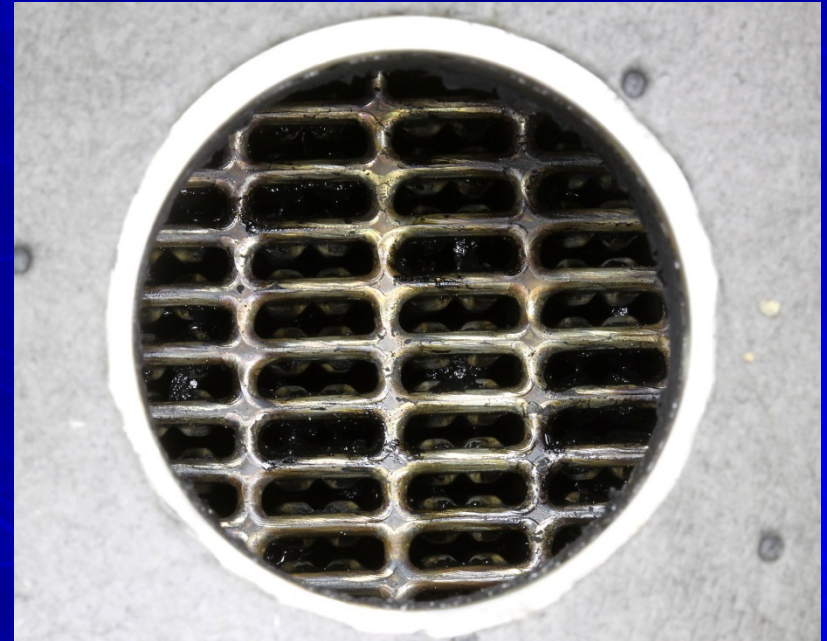
Test Sample #3

Case ID 2672579, 2/3/2012 – 33228 miles*

- Support Net indicates this is the 2nd EGR cooler for this vehicle. Replaced previously @ 14892miles

| | #blocked | #restricted | #clear |
| Before | 36 | 0 | 0 |
| After | 0 | 0 | 36 |

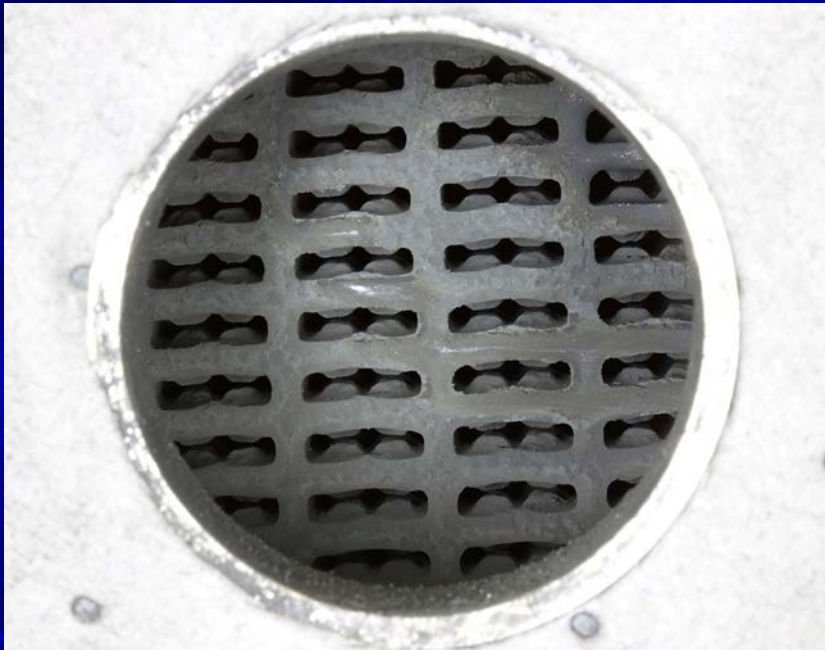
Soft powdery deposit – experience has shown this is cleanable
